# Geotechnical and Geo-Environmental Damage and its Impacts on Critical Community Infrastructure during the 2021 Western European Floods: The Case Study of Altenahr, Germany

*Keywords: 2021 Western European flood, infrastructure damage, reconnaissance observations, Altenahr Germany*

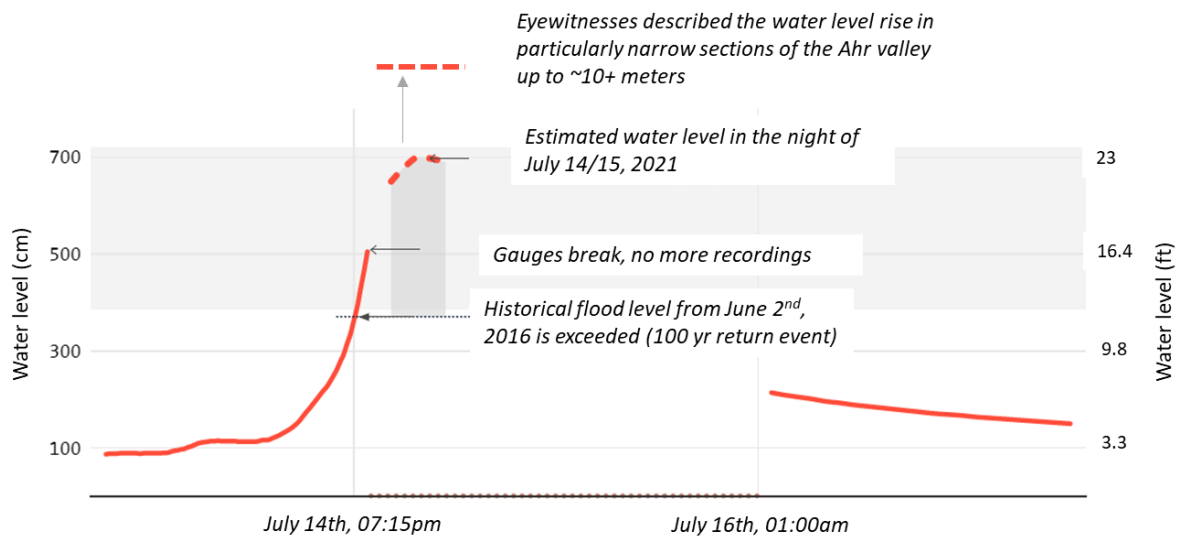
**Figure 2.** Water level rise during flood event in the district of Altenahr and loss of gauge readings (adapted from Schmid-Johannsen et al. (2021), data obtained from Hochwasserzentrale RP (2021))

Altenahr is a small district with a population of 1914 people in the county of Ahrweiler. The district consists of four smaller municipalities, namely Altenahr, Altenburg, Kreuzberg, and Reimerzhofen. However, most often all four municipalities are combined and referred to as Altenahr. The district as well as the individual municipalities of Altenahr were heavily featured in various media sources due to their extensive flood damage to infrastructure and the total number of fatalities (33), which was the second highest reported amongst any of the single districts (Schmid-Johannsen et al., 2021). Altenahr has an elevation of about 170m above sea level, and an area of 15km<sup>2</sup>. The Ahr bend (Ahrschleife) in Altenahr, a tight meander wrapping around central parts of the town, contributed substantially to the heavy, localized damage and high number of fatalities. The water level gauges along the Ahr in Altenahr exceeded its previous record of 2016: 3.71 m, discharge: 236 m<sup>3</sup>/s (Schaefer et al., 2021). In July 2021, the measuring stations broke due to flooding at a value of 5.05 m (and a discharge of 332 m<sup>3</sup>/s). Estimates for this event suggest a water level between 7 and 8 m, (in selected locations up to 10 m, Figure 2) with a discharge between 400 and 700 m<sup>3</sup>/s. Compared to the two particularly significant flood events previously recorded in the Ahr valley in 1804 and in 1910, the 2021 event suggests lower flood levels than in 1804 (estimate: ~ 1100 m<sup>3</sup>/s), and similar magnitudes as in 1910 (~ 500 m<sup>3</sup>/s) (Schaefer et al., 2021).

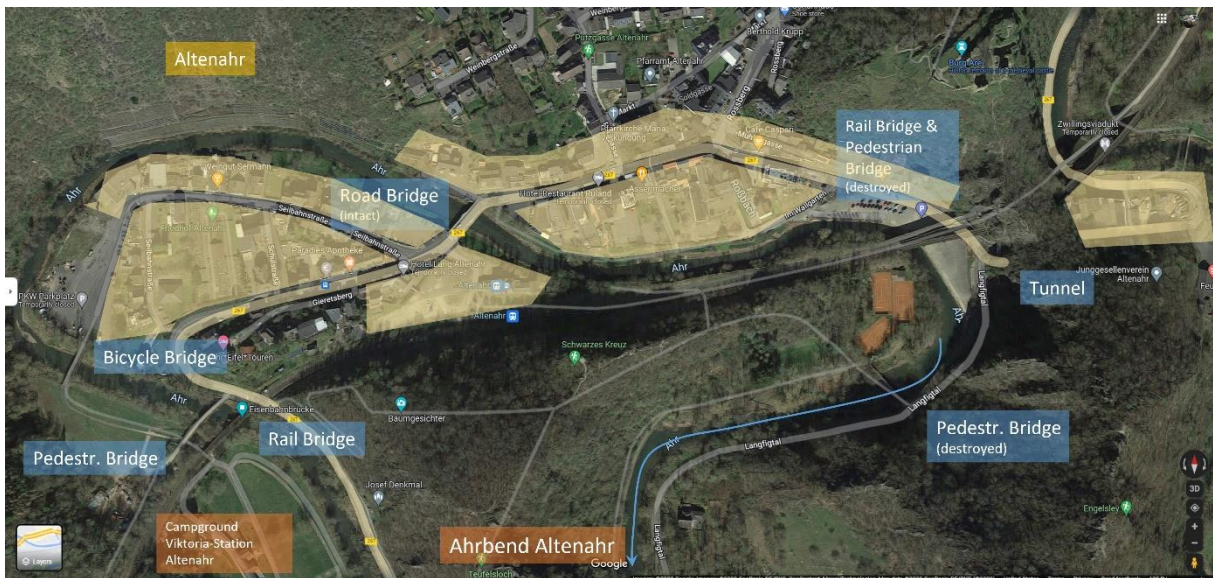
Figure 3 depicts an aerial image of Altenahr. The yellow shaded areas experienced severe damage with partial to full destruction of residential, commercial, and transportation infrastructure. Furthermore, these

areas experienced soil erosion, particularly near the sloped Ahr riverbanks, as well as sediment and debris re-deposition. In total, the Altenahr district reported 480 (80%) of all residential buildings to be heavily damaged (SWR.de, 2022). Approximately 150 of the 480 affected buildings had to be (or will be) demolished due to severe water damage and/or oil contamination, and many of them will not be given permission to rebuild in the same location due to the newly published inundation maps. Reconnaissance observations suggest the primary damage was associated with building facades, damage to lower floors due to the impact of wood and debris transported by the flood waters, as well as soil erosion near the foundation level. Figure 4 depicts examples of damage to residential buildings in Altenahr. Typical story heights in Germany are approximately 2.30m, suggesting water levels reached at least 4.0 m in many parts of Altenahr, as indicated in Figure 4. Besides the frequently observed above-ground damage shown in Figure 4 (top), Figure 4 (bottom) also depicts the remains of a washed-out residential structure, with only basement walls remaining. This failure scenario suggests acceptable geotechnical/foundation performance but indicates the lack of structural connection between the basement walls and the floor slab at the ground level (e.g., lack of continuous rebar). Several similar examples were observed in other regions of the Ahr valley, however, this type of extreme failure was less frequent than facade damage/ or removal of only parts of the superstructure.

Figure 3. Aerial map of Altenahr with heavily flood damaged areas.

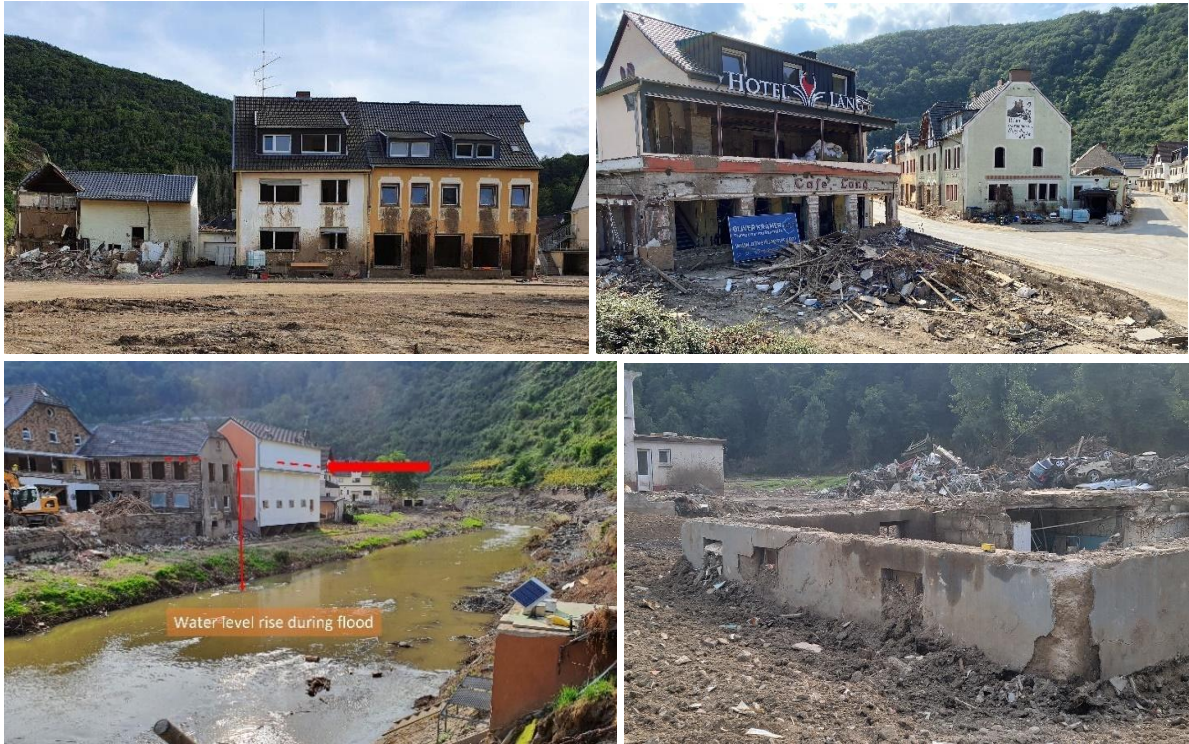
**Figure 4.** Example of structural/residential damage in Altenahr (town).

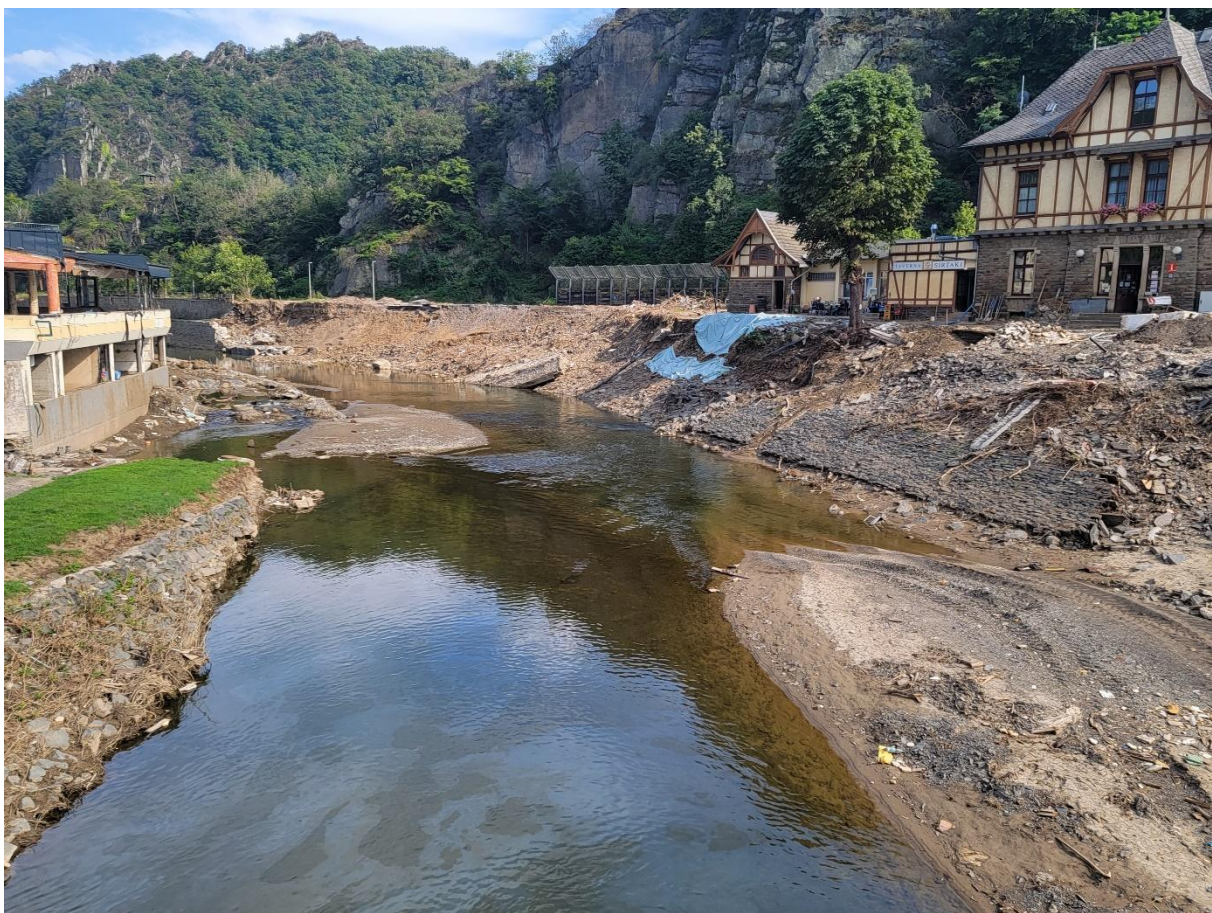
Figure 5 shows the Ahr river at the Altenahr train station, a transportation key point for the Ahr Valley tourism. The station (building to the right in Figure 5) was situated between a river meander (outer bend) and steep hill slopes (consisting primarily of rock cuts) as shown in Figure 5. Substantial riverbank erosion, damage and washout of an earth retaining wall can be seen in this photograph. Likely due to the unfavorable location of the station, slope armoring and stabilization was not effective in preventing extensive damage to the riverbanks immediately adjacent to the train station.

**Figure 5.** Soil erosion and retaining wall failure at the Altenahr train station.

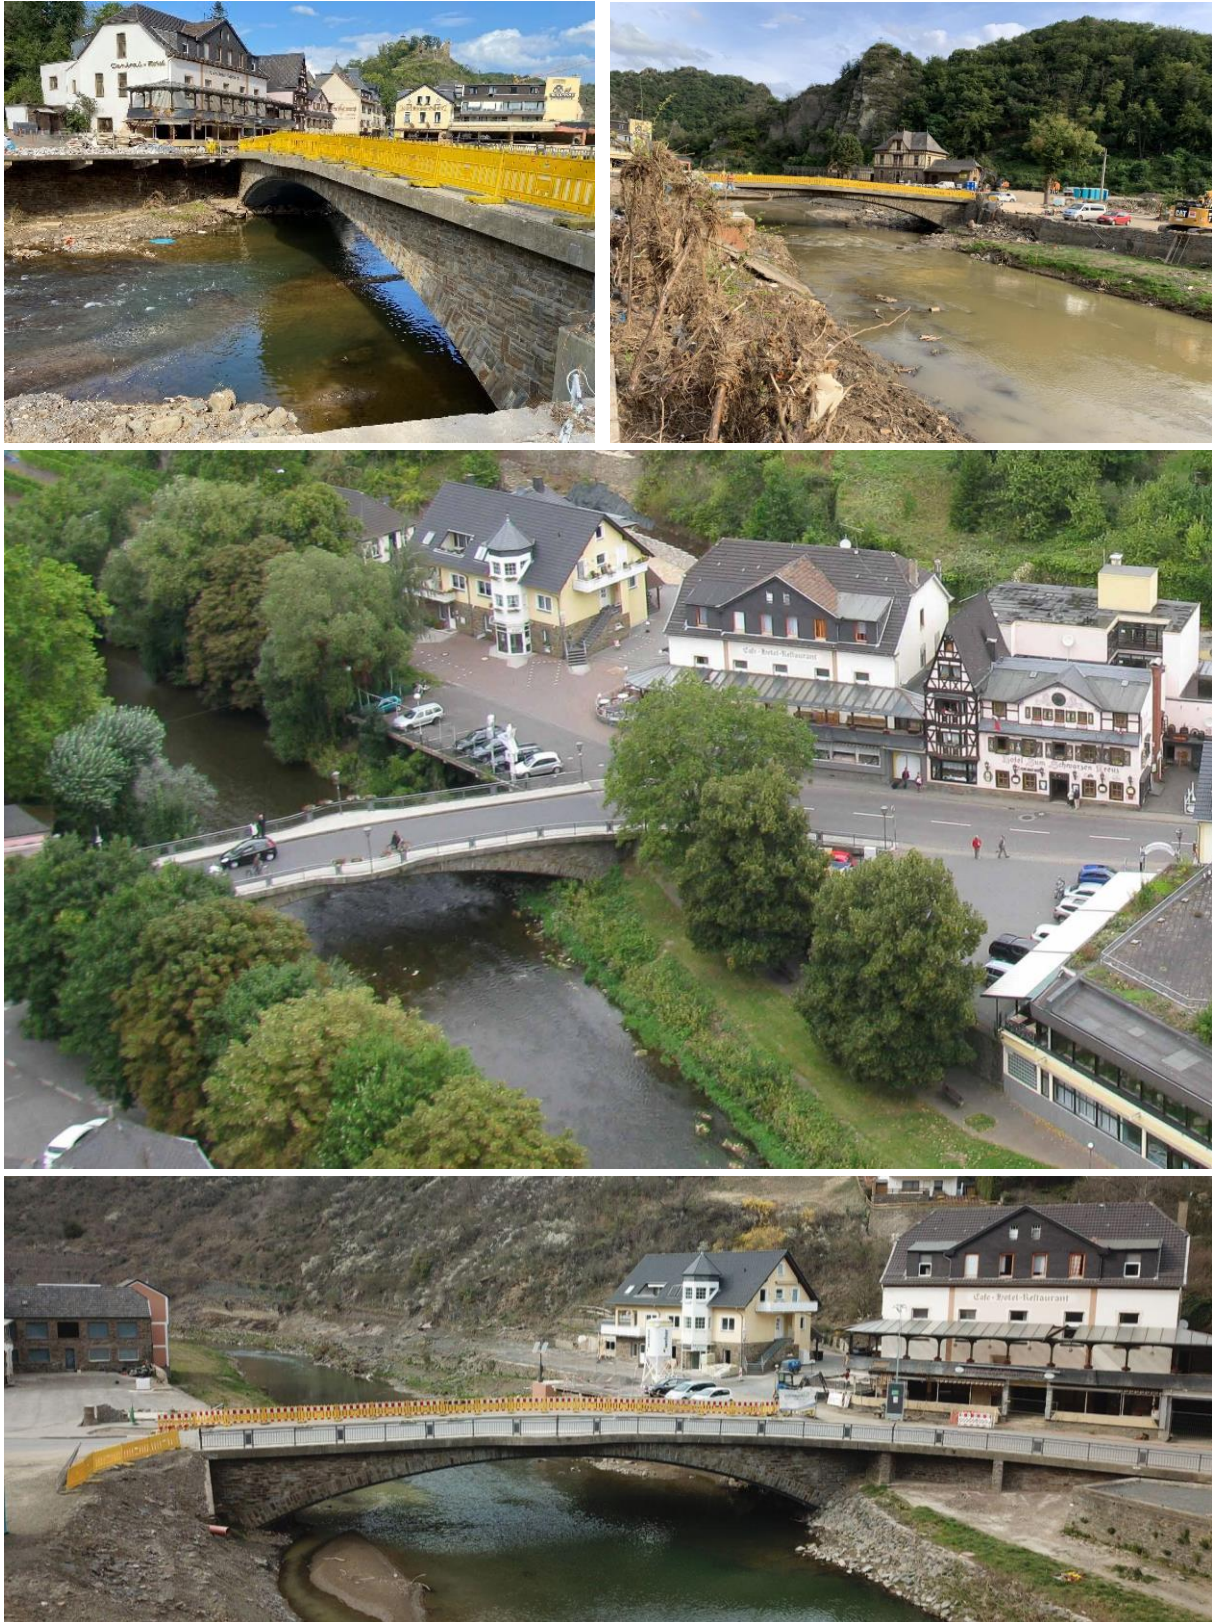
Out of the 17 bridges in the Altenahr district, only one bridge remained intact. The Altenahr road bridge, located in the town center (labelled in Figure 3 and photographed in Figure 6) remained structurally functional, allowing for post-flood traffic to resume normally upon clean-up and debris removal. This performance can be attributed in part to the favorable boundary conditions at the bridge ends. As shown in Figure 6, the bridge is connected with/to a continuous earth retaining wall (Fig. 6 top right) or has a wingwall, which prevented floodwaters from reaching behind the bridge abutment area and washing out backfill materials (as observed in many other locations). The other bridge end (shown in Figure 6 top left, center and bottom) was connected with the adjacent road through an integrated retaining wall with deck (Fig. 6 middle/bottom). Figure 6 shows the bridge at the time of the reconnaissance visit (top), the pre-flood condition (center), as well as eight months after the flood event during a second visit of the reconnaissance team (bottom, March 2022).

**Figure 6.** Photographs of the only structurally intact bridge in Altenahr following the flood, Top: Photos of abutment regions of the bridge in Aug 2021, Middle: Pre-flood aerial photograph, Photo Credit: Heinz Grates (<https://www.aw-wiki.de/w/index.php?curid=36263>), Bottom: Aerial photo taken by the GEER team in March 2022, showing the bridge after clean-up work.

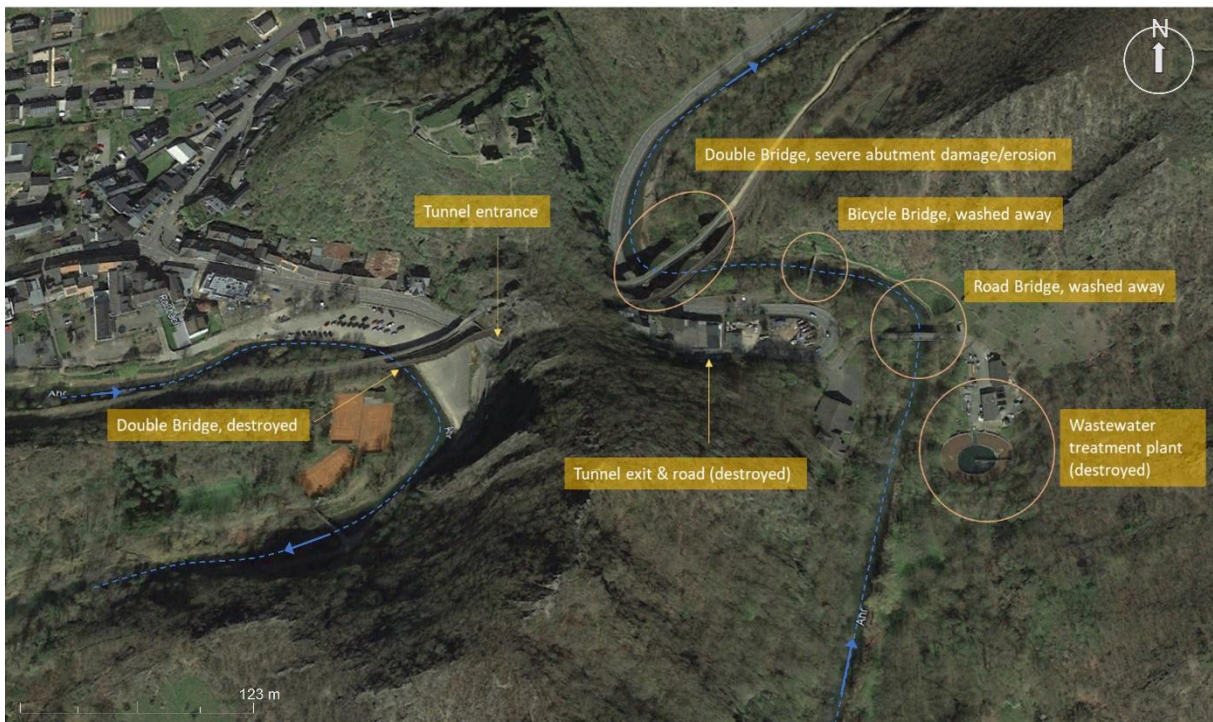
The tunnel exit site in Altenahr has been one of the most featured damage locations of the Ahr valley in Germany. Figure 7 shows an aerial map obtained from Google Earth and various infrastructure facilities near the affected site. This location is of particular interest for documenting how soil relocation near the tunnel and intersection with the Ahr river relate to local hydraulics, geology, and abundant infrastructure. The location features multiple key infrastructure items forced to be tightly grouped due to the restrictive, steep valley, and the river. The presence of this infrastructure, in particular the tunnel, led to a significant change in local hydraulics.

The *Ahr* river makes a bend around the tunnel (which is located south of the photo, but not visible in Figure 7). Aside from the tunnel entrance and exit areas, Figure 7 also describes the infrastructure around the tunnel and its performance during the flood. Flood waters flowed through the tunnel from the tunnel entrance on the west side, nearly filling the opening cross-section. The relatively small cross-sectional opening of the tunnel caused a high-velocity water efflux that exited on the east. The double bridge (rail/bicycle) on the west side of the tunnel was also destroyed during the flood.

**Figure 7.** Google Earth Aerial View of the tunnel entrance/exit site in Altenahr prior to the flood (3/2020).

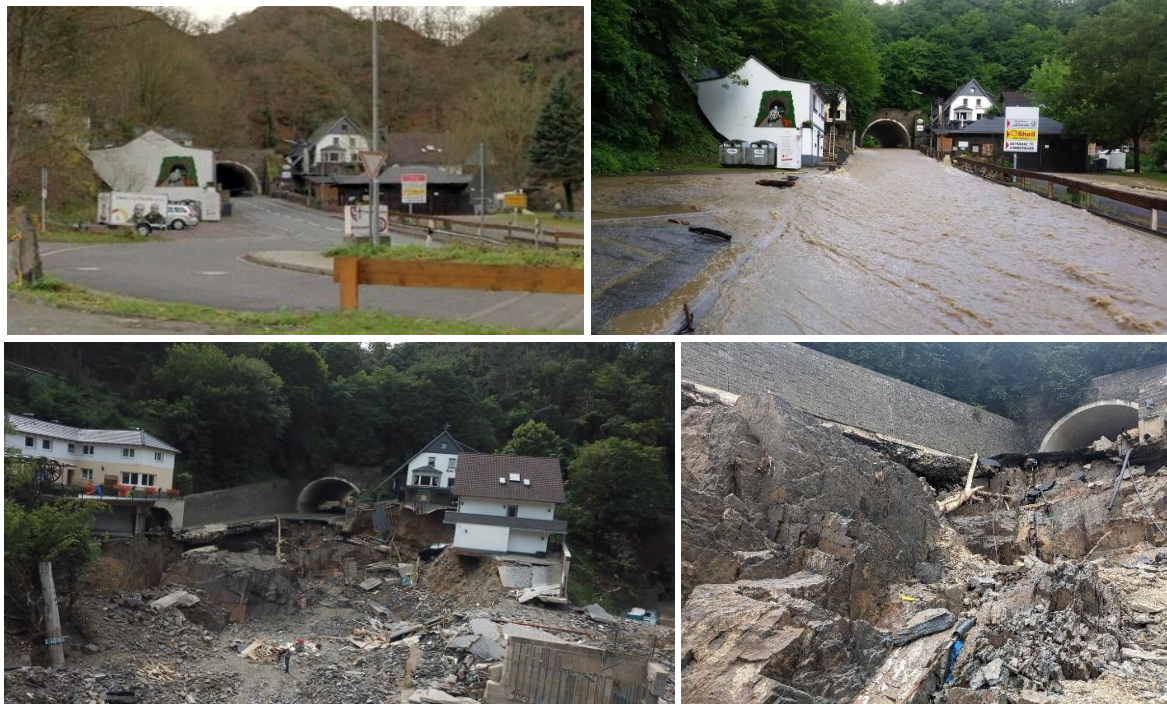
Figure 8 (top) shows a Google Street View of the tunnel exit in May 2021 prior to the 2021 flood event, followed by a reference photograph of the tunnel exit during the 100-year return flood in 2016 (Fig. 8 (top, right)). Figure 8 (bottom) shows the tunnel exit and surrounding area on August 13, 2021, approximately four weeks after the flood. The tunnel street (Tunnelstrasse) was completely destroyed by the water efflux rushing out of the tunnel exit and exposed underlying bedrock to depths of 9 m. Figure 8 (bottom) also shows the jointing orientations in the underlying rock, damage to the adjacent residential buildings, and the large volume of material that was eroded downstream of the tunnel exit. The eroded crater-like feature outside the tunnel exit had approximate dimensions of 9 m in depth and 50 m in width. A similar feature was documented during the 1910 flood at the east side of the tunnel (Gaertner, 2022).

**Figure 8.** Top left: Google Earth/Maps Street View of the Altenahr tunnel from May 2021; top right: photo during the June 2016 flood event (Source: [https://www.altenahr.de/index.php?id=26&publish\[id\]=9709&publish\[mode\]=overview&no\\_cache=1#18](https://www.altenahr.de/index.php?id=26&publish[id]=9709&publish[mode]=overview&no_cache=1#18)); bottom: photos by the reconnaissance team after the 2021 flood, August 2021 (50.5165261, 6.9975355)

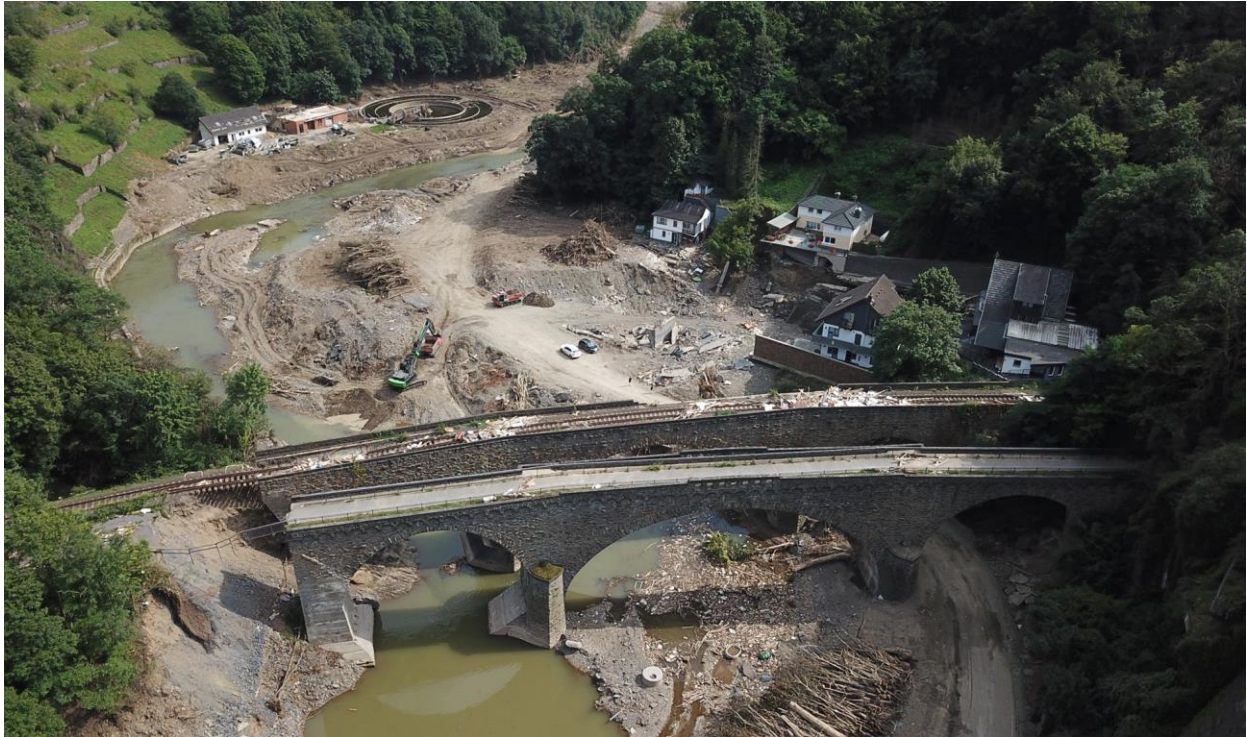
Near the tunnel exit, a double bridge connected railway tracks and a road across the Ahr river. Figure 9 shows the severe damage to both bridges, but also the extent of sediment relocation and streambed destruction at this location. The image also illustrates a key geological and topographic characteristic of the Ahr valley: its steep slopes and limited width of the river valley. This topography has been highlighted as a key issue that led to the severity of the flood in the Ahr valley. Figure 10 shows an elevation profile at the location of the double bridge and surrounding area. The bridge is situated near profile #2 in Figure 10 (right). The maximum slope of the adjacent hillside was approximated as 76.9% (cross-section 2). Figure 10 also illustrates the extent and width of soil erosion and sediment redeposition along the Ahr river in the vicinity of Altenahr (Fig 10, left).

**Figure 9.** Aerial photograph of the double bridge (rail/road) at the tunnel exit Altenahr

In the background of Figure 9, a water treatment plant is visible which was also affected by the flood event. The water treatment plant (shown in Figure 14) was irreparably damaged (General Anzeiger, 2022), and wastewater was directly discharged untreated into the Ahr River according to authorities in Mainz, the capital of Rhineland-Palatinate (RP). This incident was not isolated and the Altenahr treatment plant was one of several plants (including its canalization) that could not be repaired. Approximately 30 Million Euros were allocated for the reconstruction of sewers and wastewater treatment plants in the Altenahr district. However, this allocation is only a fraction of the more than 183 Million Euros needed to repair the major wastewater facilities within the Ahr valley and remediate wastewater-based environmental damage to the region (General Anzeiger, 2022). The wastewater treatment plant experienced flood water influx from both upstream and downstream directions due to (1) water flushing through the narrow stretches of the Ahr bend (upstream), and (2) water being backed up as efflux from the tunnel hits the steep slopes across the tunnel exit. The adjacent structure of the wastewater facility was also destroyed. Current estimates by government officials suggest that  $\frac{1}{3}$  of the canalization in the Ahr valley is damaged, destroyed, or entirely washed away. The restoration of the entire sewer system is expected to take 10 years. Small mobile wastewater treatment plants are currently being erected to prevent continued discharge of untreated water into the Ahr (SWR.de, 2021).

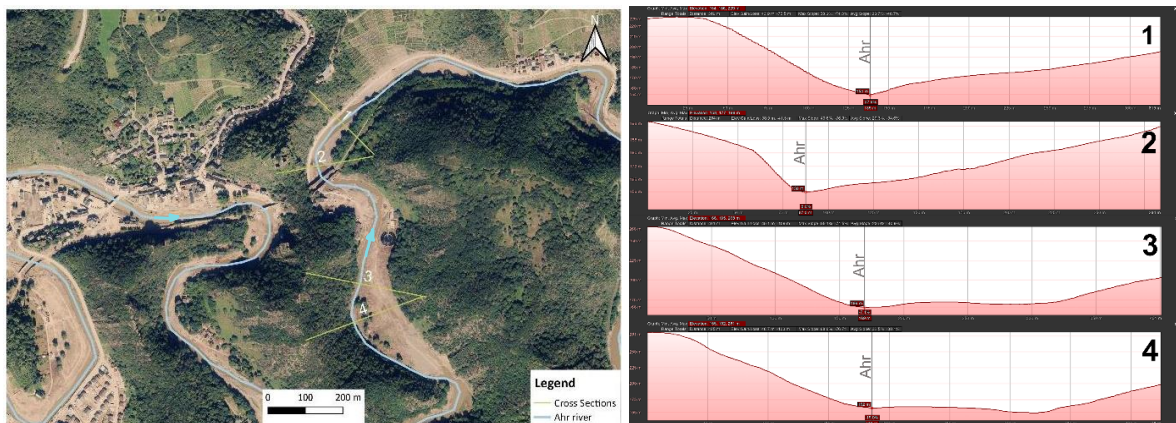
**Figure 10.** Left: Plan view of tunnel exits and location of cross-sections; Right: Elevation profiles in near vicinity of the Altenahr tunnel exit

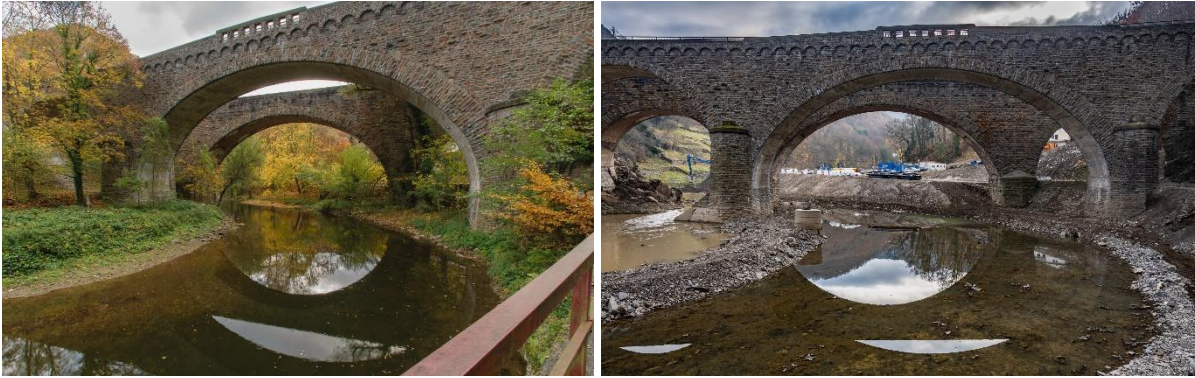
The bridge has a total height of 18 m, and a length of 100 m. The bridge arches have a clear cross-section of flow of nearly 33 m in width and 15 m in height. The bridge piers have a thickness of 5.3 m and an enlarged sloped reinforced mantel at the bottom of the piers. The bridge was placed on shallow reinforced concrete footings. No structural damage was observed at any of the intermediate bridge supports. A comparison of before-after imagery (Figures 9, 11) suggests the pre-flood channel of the Ahr river through the middle arch of the bridge (Figure 11, left), while the immediate post-flood route of the river occurred primarily through the left arch of the bridge as shown in Figure 9. This left side of the bridge was the most severely affected, with substantial erosion and damage to the abutment region (Figures 9 and 12, left). Following restoration and clean-up work in the area, the river was guided back into its pre-flood channel (Figure 11, right).

**Figure 11.** Before and photos of double bridge at tunnel exit taken in upstream direction, photo credit: Heinz Grates, Source and access at <https://www.aw-wiki.de/w/index.php?curid=67031>; Left: Pre-flood, Right: Post Flood and post-river rerouting back into its original riverbed

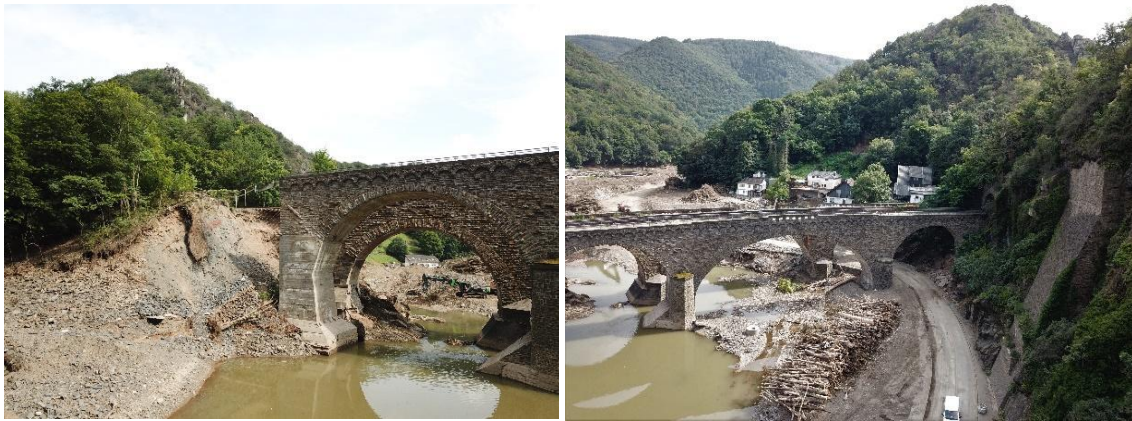
Figure 12 shows close-up photos of the abutment region around the double bridge. The extent and elevation of the washed-out abutment area provides an estimate of the water elevation (~18 m above its original water level) within this narrow stretch of the valley. Remnants of the damaged train tracks span between the bridge and the adjacent hillside. The bridge abutment area in Figure 8 (left) consists of an un-engineered connection between the bridge arch and adjacent natural hillside, likely backfilled with excavation spoils at the time of construction. The lack of wingwalls and armoring likely contributed to the extensive erosion in the vicinity of the abutment. However, the large cross-sectional flow area of the bridge arches and additional flow area created by the abutment erosion likely mitigated structural damage to the bridge structure itself.

**Figure 12:** Photo of the abutment region of the double bridge, August 13<sup>th</sup>, 2021. Left: Washed out abutment area, Right: bridge abutment area intact and connected to adjacent rock slope

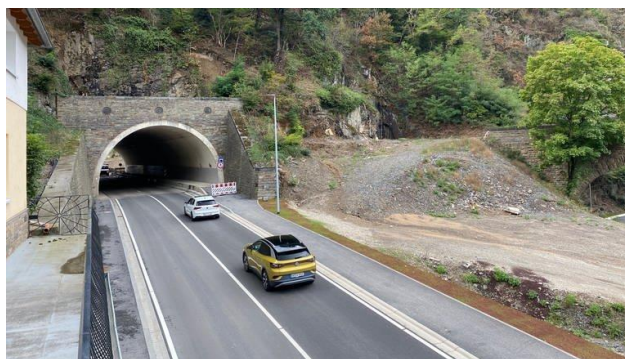
**Figure 13.** Tunnel street at opening in September 2022

In September, 2022 the tunnel exit was reopened following road construction of nearly 2.43 Million Euros. Four adjacent residential structures were removed (Gaertner, 2022). According to city officials, the extent of future flooding is expected to be less due to increased asphalted surfaces near the tunnel exit and due to lack of easily-eroded cobblestone sidewalks.

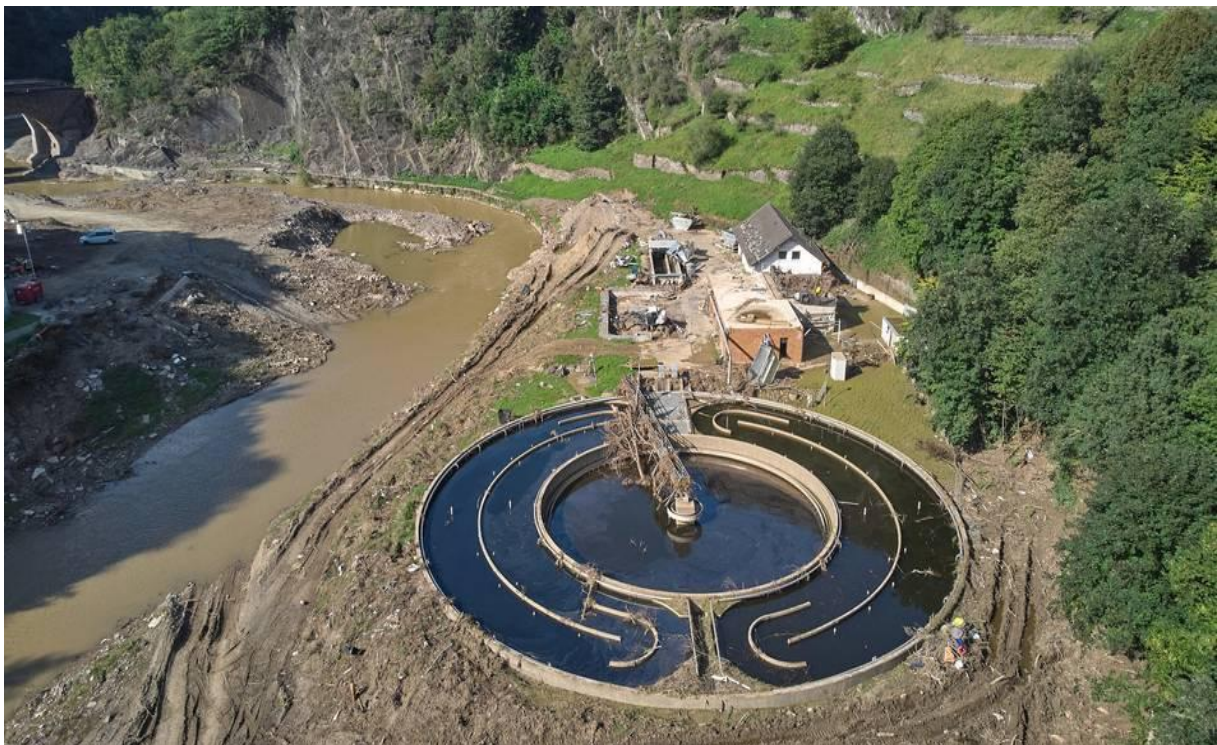
**Figure 14.** Wastewater treatment plant Altenahr following the 2021 flood, Source: DPA/Thomas Frey

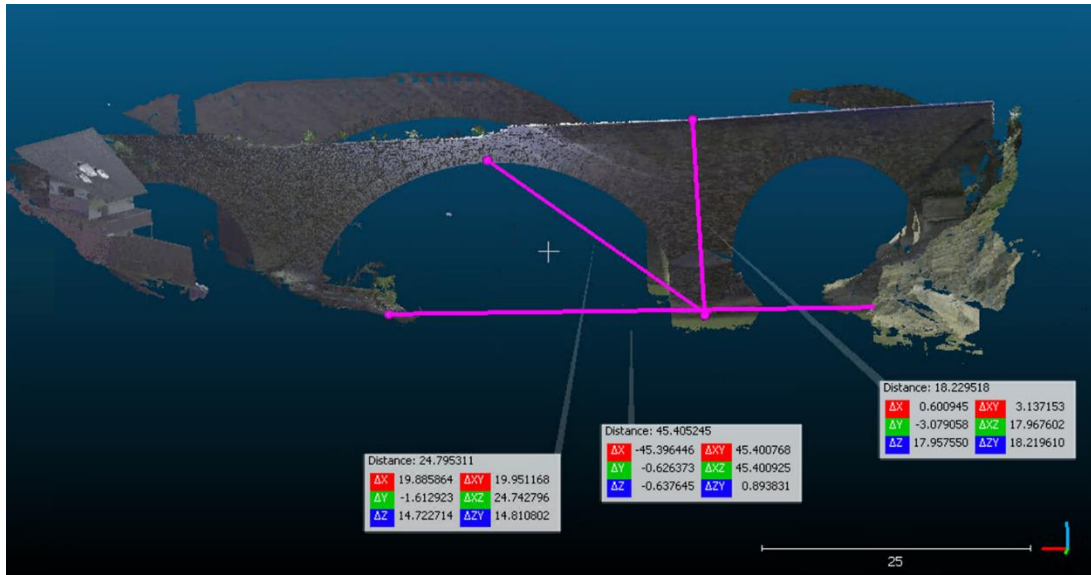
Figure 15 depicts an excerpt of initially collected 3D point cloud data of the double bridge using terrestrial LiDAR. Data processing from this location (as well as most others) is still ongoing. The generation of the point cloud model from terrestrial LiDAR allows for geometric measurements of features of interest. As shown in Figure 15, estimates of the total bridge height, clearance height, and cross-sectional distance of the river were found to be 17.96m, 14.72m, and 45.50m respectively. Similar measurements are possible in point clouds generated from UAV imagery, albeit with less accuracy. Aside from measurements depicted in Figure 15, possible future geometric measurements include volume of soil lost due to scour and erosion, angle of pier tilt, deck deflection, and the dimensions of resulting cracks in decks or piers. These data provide meaningful information for numerically modelling water-structure-soil interaction at the bridge location.

**Figure 15.** 3D point cloud excerpt derived from terrestrial LiDAR at the Altenahr double bridge. From left to right, measurements of the bridge clearance height ( $\Delta Z = 14.72\text{m}$ ), river cross sectional distance ( $\Delta X = 45.50\text{m}$ ), and total bridge height ( $\Delta Z = 17.96\text{m}$ ) were measured using the LiDAR derived point cloud.

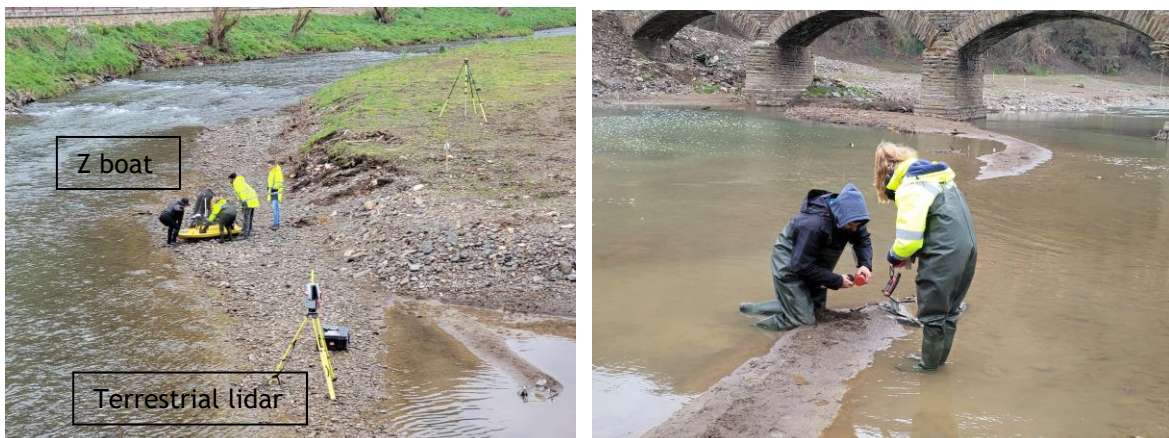
At five selected locations in the Ahr Valley, including in Altenahr, in-water measurements including bathymetry and riverbed sediment classification were performed using different geo-acoustic surveying tools (single beam sonar, side scan sonar, low-frequency chirp sonar), physical testing of riverbed sediments using a portable free fall penetrometer, and sediment sampling. Figure 16 (left) shows the deployment of a remotely operated vehicle equipped with a single beam sonar for bathymetric measurements, as well as the terrestrial lidar system used. Figure 16 right shows sediment sampling of flood deposits. Both images represent a severely damaged double bridge site just upstream of entering the town of Altenahr center. While this data is still in processing, it will provide seamless data sets connecting subaerial topography and subaquatic bathymetry to enable a full picture of sediment relocation during the flood event. Also, scour depths around bridge piers and abutments were determined. Most significant sediment deposition sites were easily identified by surficial fine-grained soft sediments, while erosion hotspots represented significant bathymetric features, or bedrock, cobbly and gravelly surfaces stripped from any more mobile sediments. The combination of subaerial to subaquatic elevation mapping and sediment characterization represents a unique data set for water-structure-soil interaction modelling and investigation of the detailed processes that resulted in the severe damages.

**Figure 16.** Left) Deployment of Z-boat for bathymetric measurements in the Ahr river in just upstream of the town entrance of Altenahr. Right) Sediment sampling in the same location.
