Methods for Detecting Cavities Caused by Beavers in Forelands and Levees

Field survey at the Oder River in Brandenburg/Germany

Torsten Heyer (torsten.heyer@tu-dresden.de), Dirk Fleischer; Institute for Hydraulic Engineering and Technical Hydromechanics, TU Dresden (Germany)
Jörg Steidl; Leibniz-Centre for Agricultural Landscape Research (ZALF) e. V., Müncheberg (Germany)

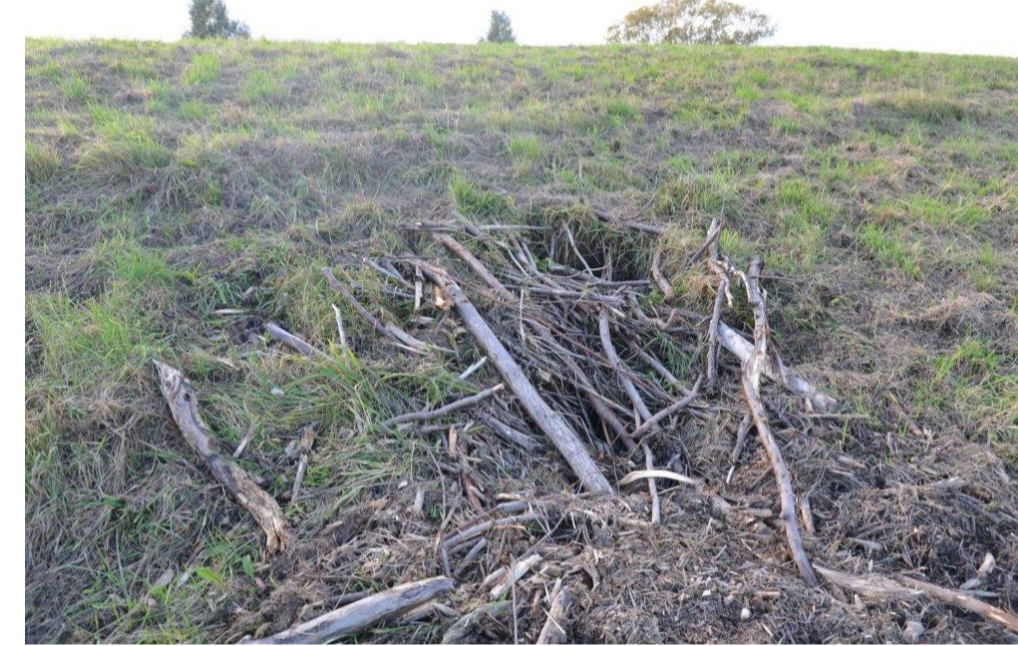
Figure 2 – Entrance to a beaver-caused cavity system in a river levee (Photo: LfU Brandenburg)

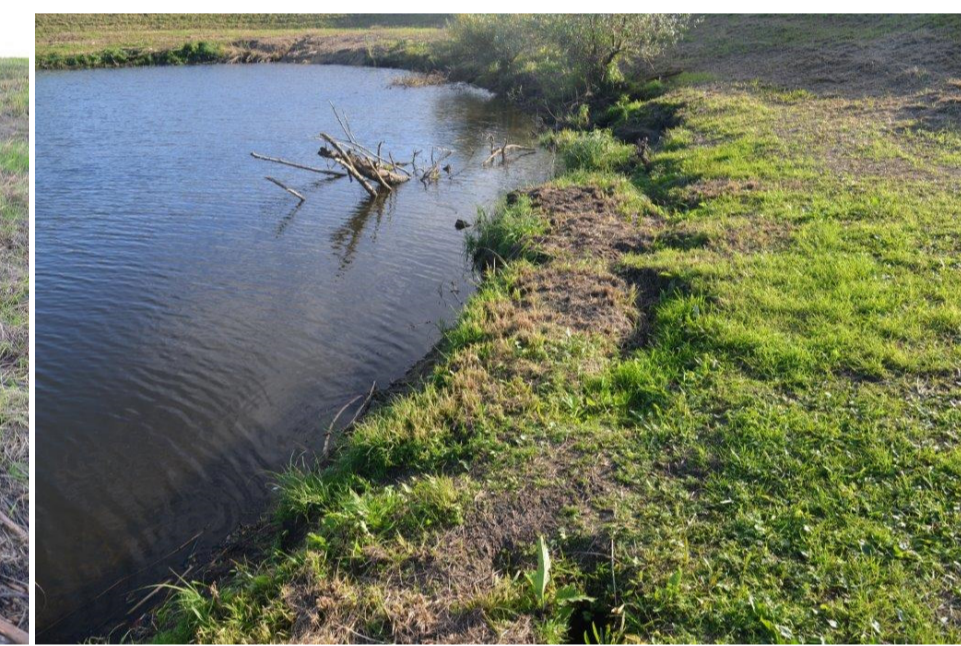
Figure 3 – Failure foreland sections due to beaver-caused cavities (Photo: Krüger)

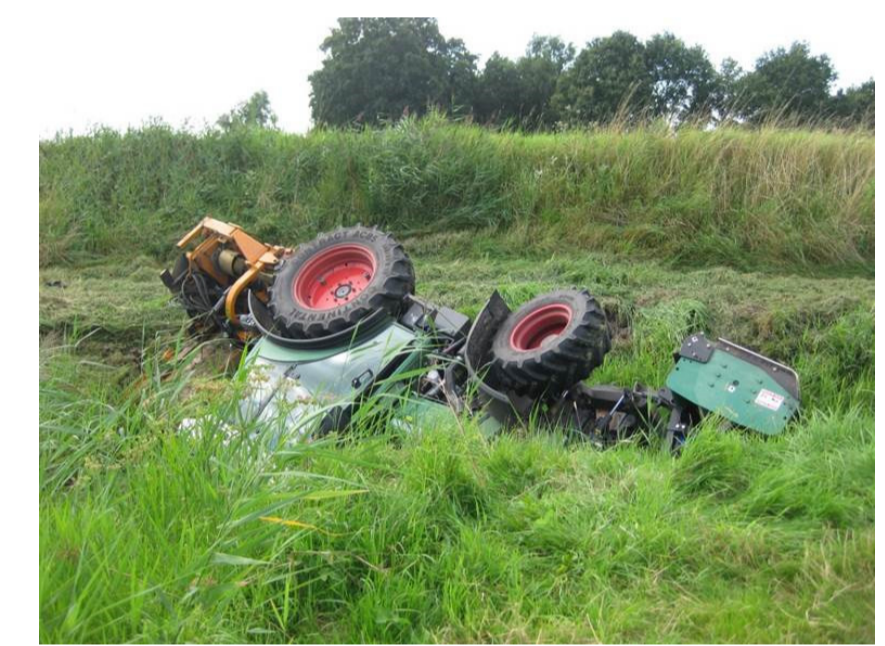
Figure 4 – Accident during river maintenance works due to cavities (Photo: Van der Steen)

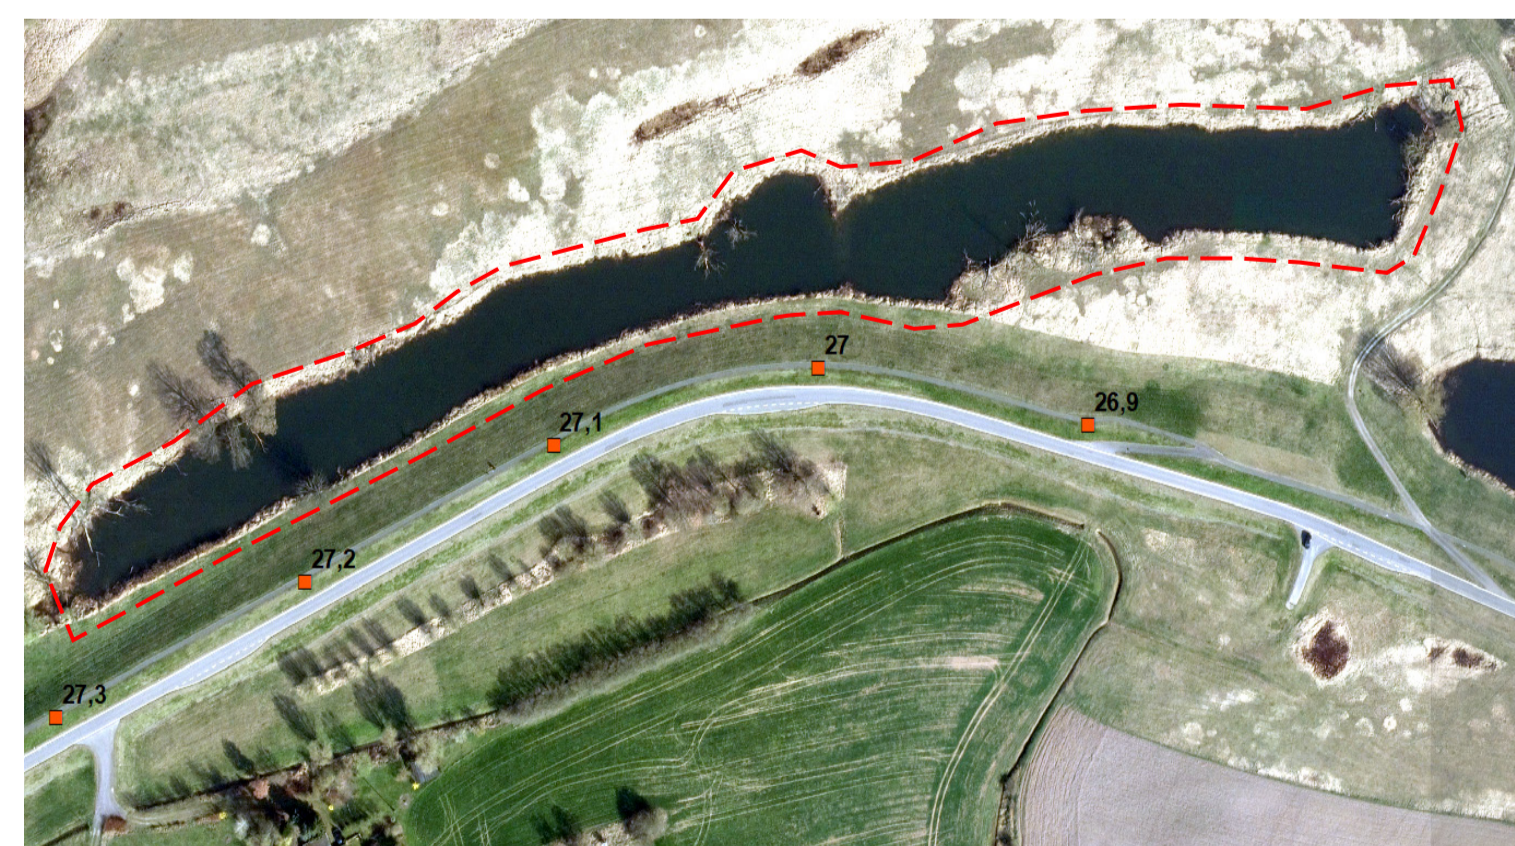
Figure 5 – Investigation area at the Oder River in Brandenburg/Germany - Oxbow lake along the waterside toe of a flood levee

As a result of an initial research, the following 10 methods were tested in a field survey (partly also in laboratory pre-tests):

- Ground penetrating radar (GPR)
- Frequency domain electromagnetics (FDEM)
- Microwave sensing
- Electrical resistivity tomography (ERT)
- Geomagnetism
- Tracking dog
- Multispectral imaging
- Thermal imaging
- Satellite radar interferometry (InSAR)
- UW-photogrammetry (UUV, GoPro)

The validation of the measured data was carried out by means of **penetration tests**.
