Beaver Burrowing Activity in Levees

Characteristics, Countermeasures, Cavity Detection

International Beaver Burrowing in Infrastructure Symposium (IBBI)

Wageningen (NL), February 3rd, 2025

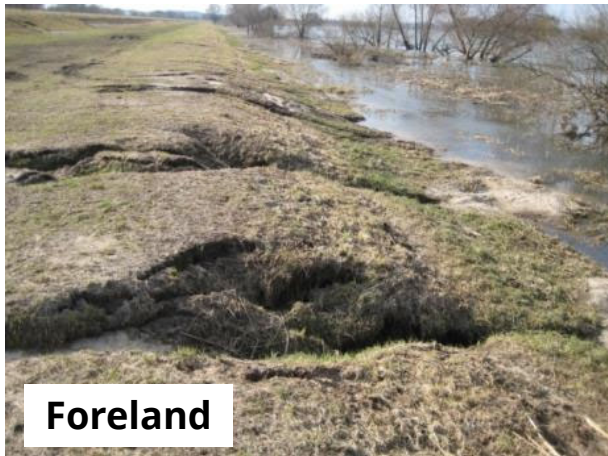
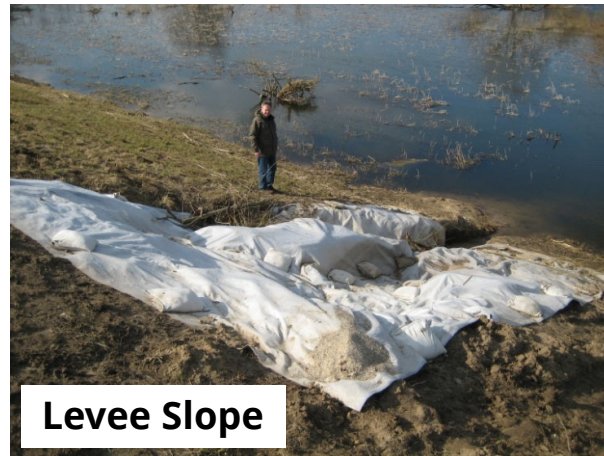
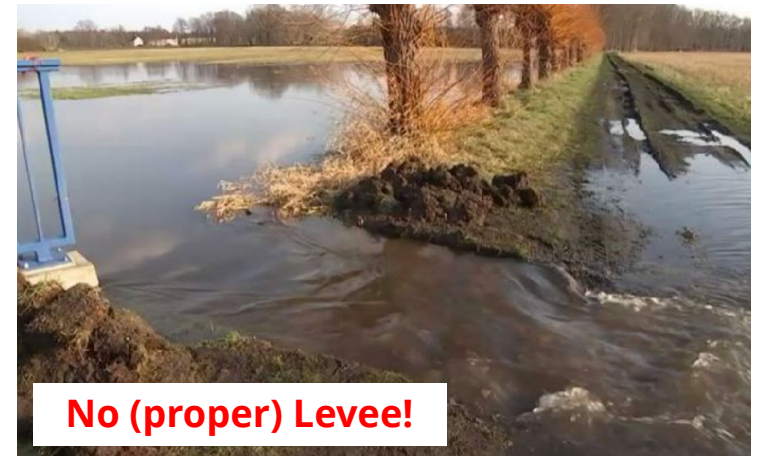
- Cavities (tunnels, tunnel systems, dens) and surface damages at
 - ▣ River banks → erosion and sediment input (small water courses)
 - ▣ Foreland → danger to river maintenance works
 - ▣ Levees (on water- and landside) → reduced reliability → risk increase
- Flood at Oder River in 2010: 550 Damages incl. 150 larger tunnel systems in levees (10-20 m into levee)
- most damages in levees, if distance to main river bed is < 20 m

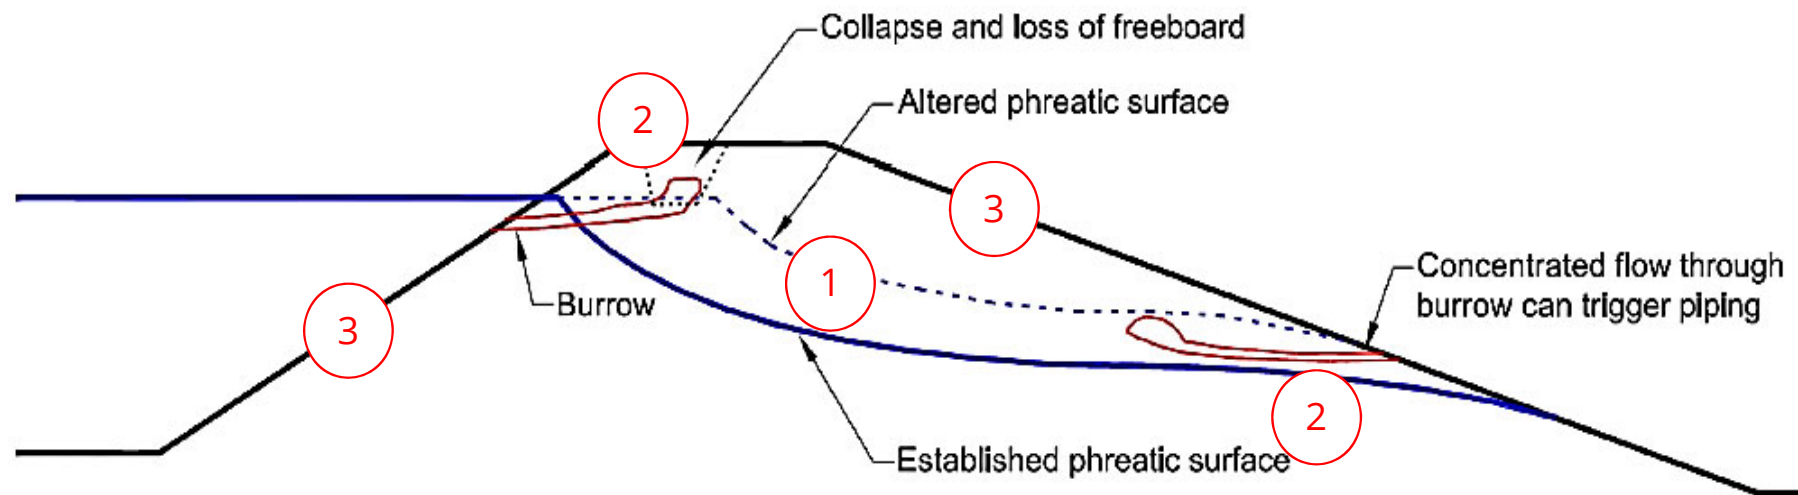
Source: Cobos Roa (2015), modified

- 1) Altered seepage behavior
- 2) Structural instability
- 3) Decreased erosion resistance → less important with regard to beaver activity
 - ▣ Indirect hazards (tree felling, blocking of culverts, etc.)

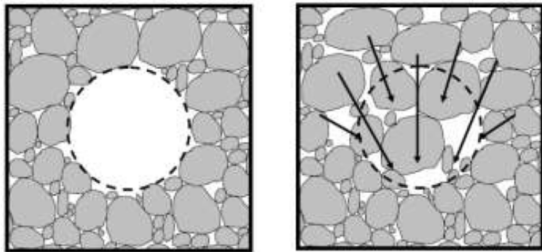
Collapse of Tunnel System

- Loss of Freeboard
- Overtopping
- Breaching

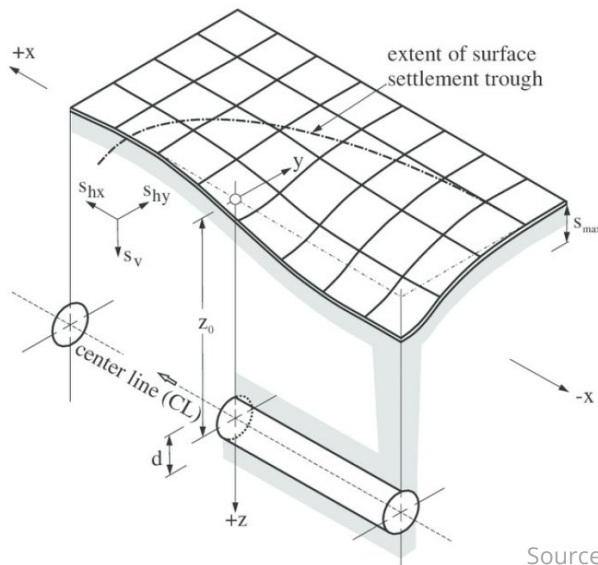
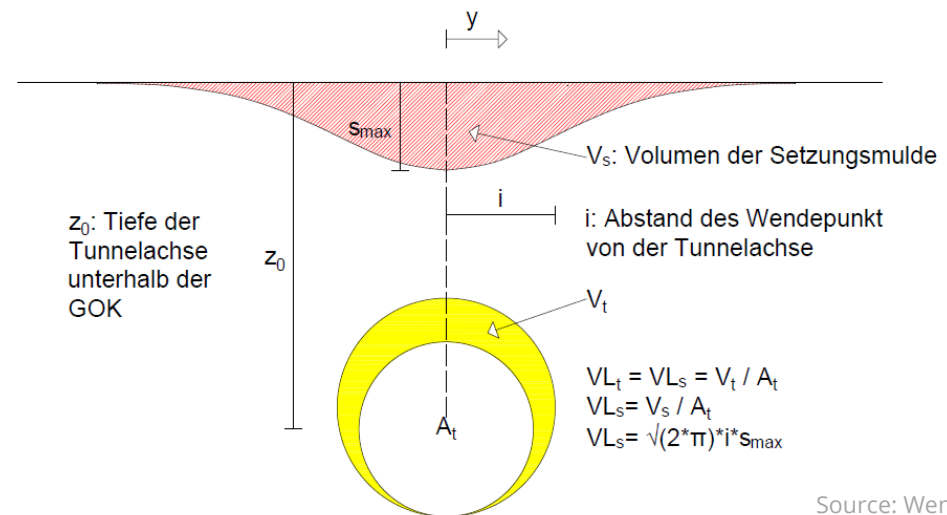
Source: Wendler (2021)

Investigations Wendler (2021):

- Deformation of cavities and earth surface can be predicted by analytical and numerical models (Analogy: Tunnel engineering)
- Goal: “satellite based detection” (e.g. InSAR) could not be achieved

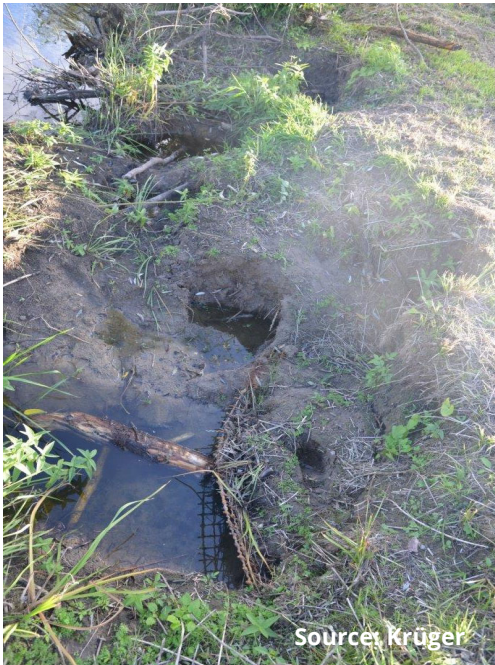
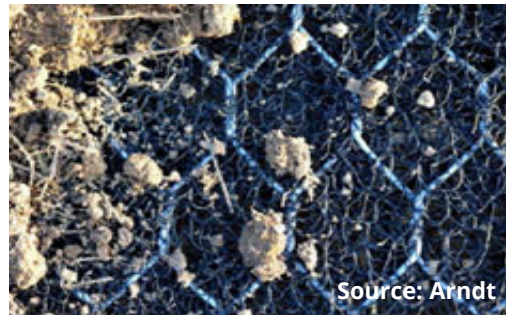
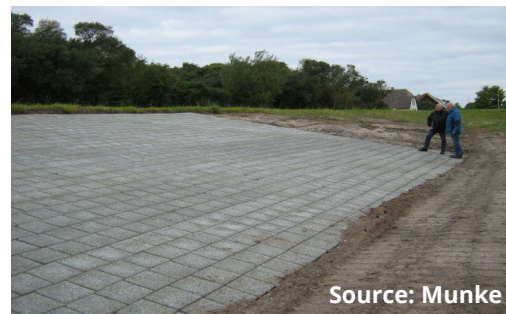
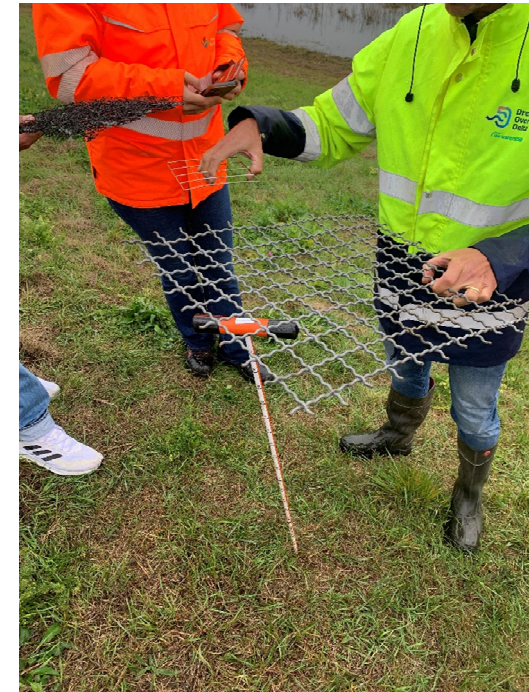
Mechanical Barriers

- **Technical solutions:** Coated wire mesh (corrosion!?), natural & artificial stones, sheet pile walls, ...
- **Appropriate placement** (location, extent) **and construction crucial** for effectiveness
- **Durability und sustainability** must be considered (**maintenance and environmental issues!**)

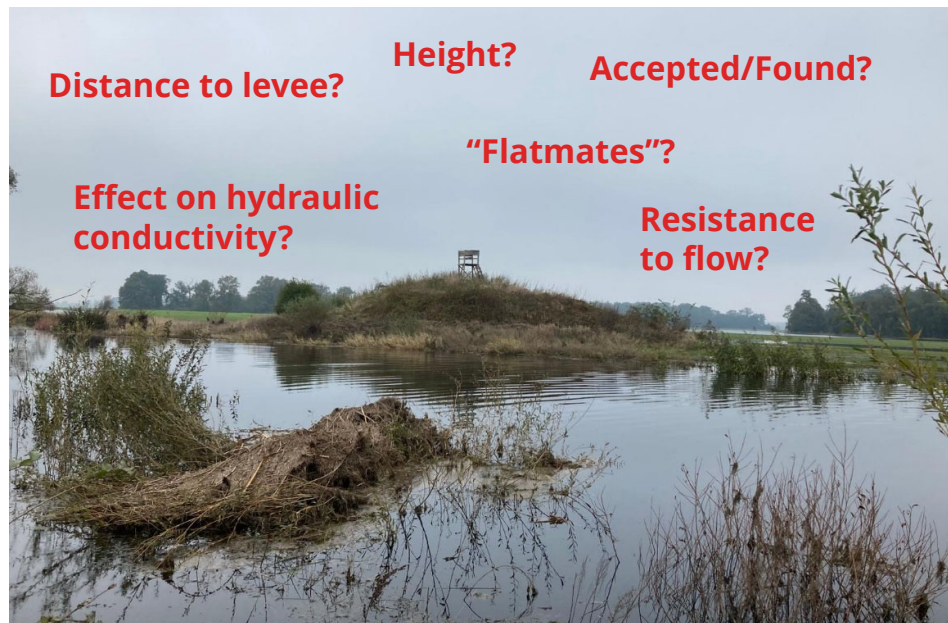
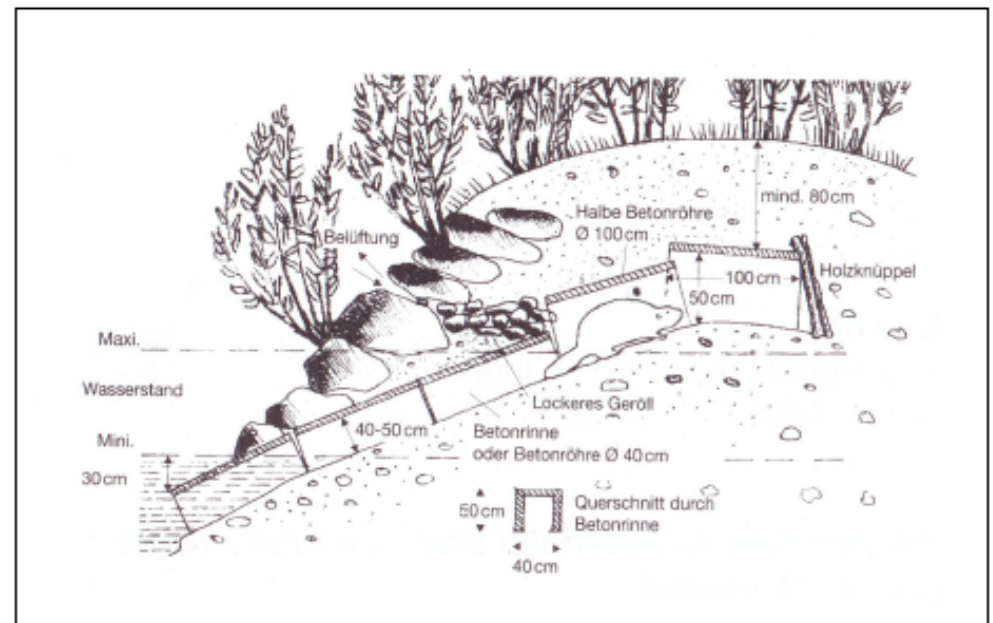
Wildlife Rescue Hills

- Only in locations, where hills are **not critical from a hydraulic point** of view, e.g. wide flood plains
- **Not applicable in narrow river sections** due to backwater effect

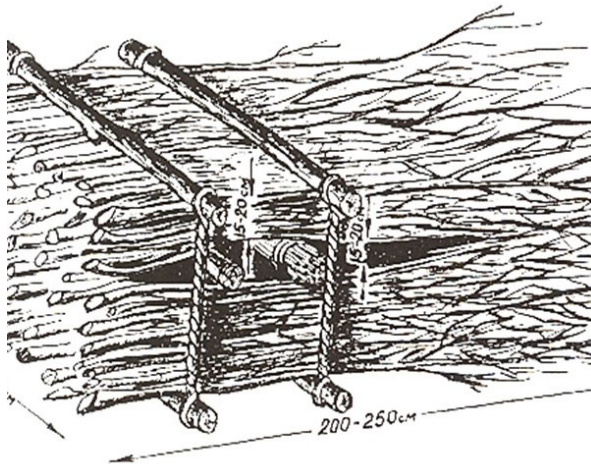
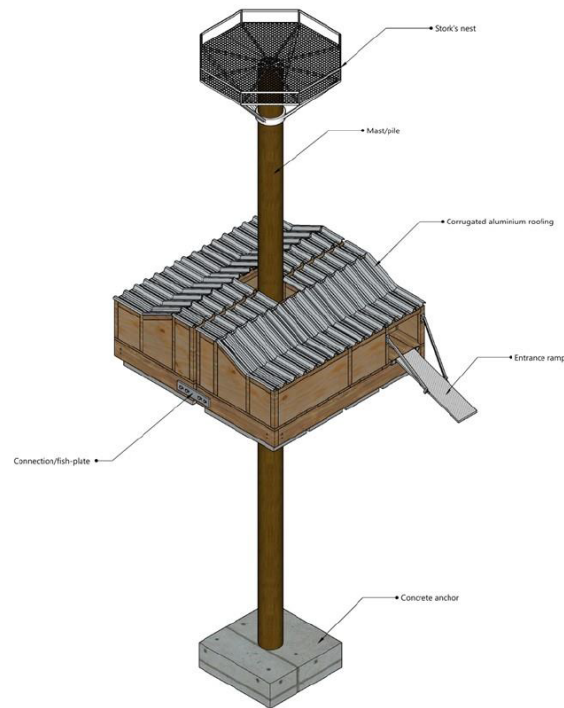
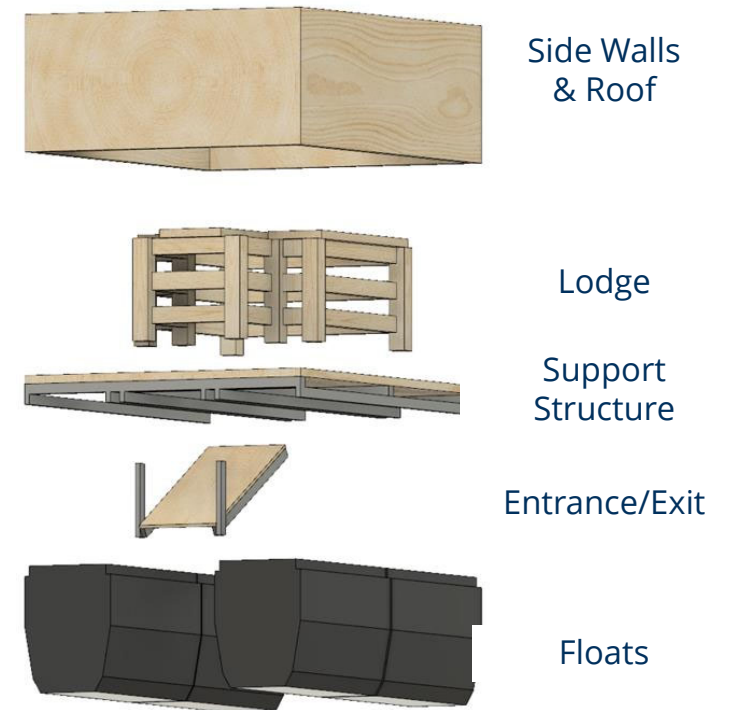
Floating Beaver Refuges

- Idea: provision of **alternative (better?) shelters**
- **Feasible** from technical point of view → **reasonable** from biological point of view?

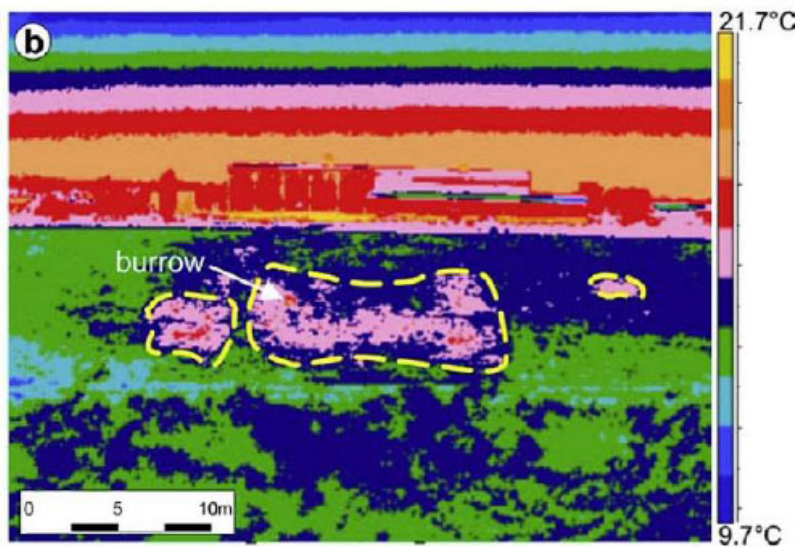
Thermal Imaging

→ **Surface Temperature**
cooler or warmer?

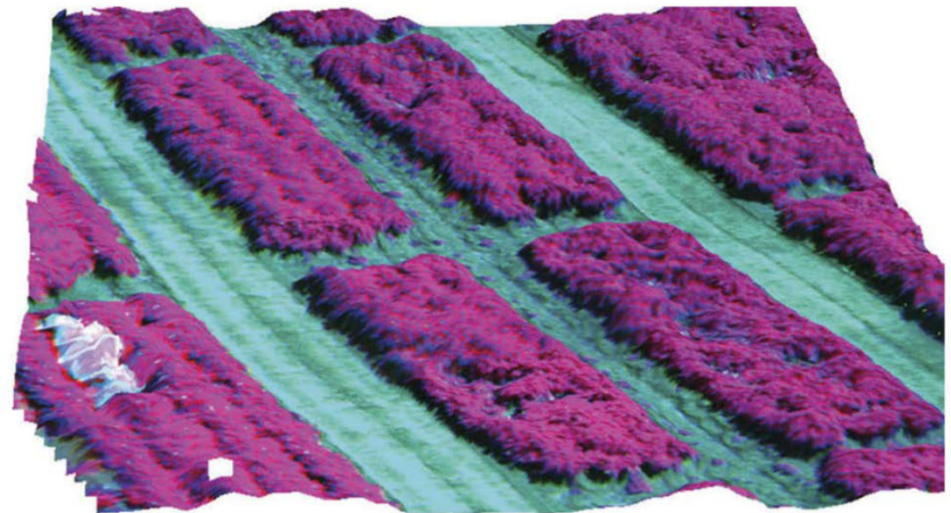
Multispectral Imaging

→ **Plant Stress**
low soil moisture content?
